**SUBJECT: FINAL AREA 5 TREE REMOVAL GAMMA SURVEY AND SAMPLING  
TRIP REPORT, FEBRUARY 2017 – NIAGARA FALLS BOULEVARD  
RADIOLOGICAL SITE, NIAGARA FALLS, NIAGARA COUNTY, NEW  
YORK**

**FINAL AREA 5 TREE REMOVAL GAMMA SURVEY AND  
SAMPLING TRIP REPORT, FEBRUARY 2017**

Niagara Falls Boulevard Radiological Site  
Niagara Falls, Niagara County, New York

**SITE NAME:** Niagara Falls Boulevard Radiological Site  
**DC No.:** RST3-03-F-0095  
**TDD No.:** 0007-0014  
**CERCLIS ID:** NYN000206699  
**EPA ID:** A23Q  
**EVENT DATE:** February 2, 2017

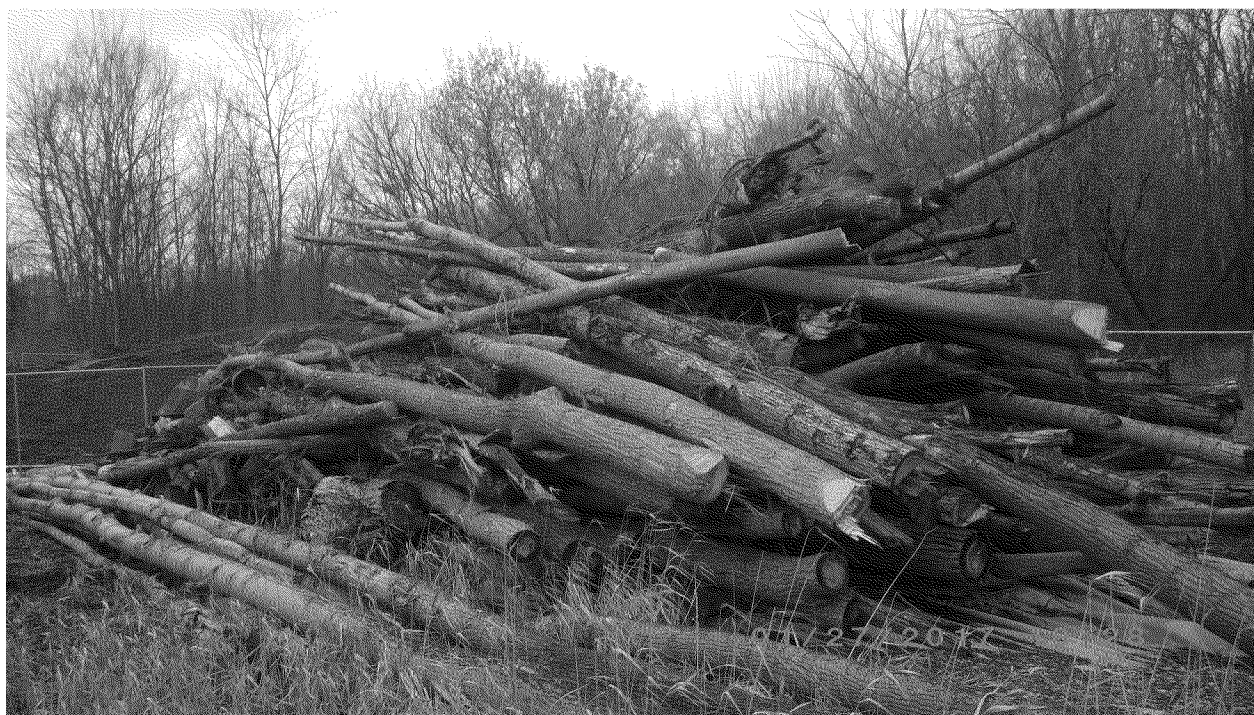
**Photograph 1:** View of trees removed from Area 5 which were placed in a pile at the initial staging area of the Niagara Boulevard Radiological Site (the Site).

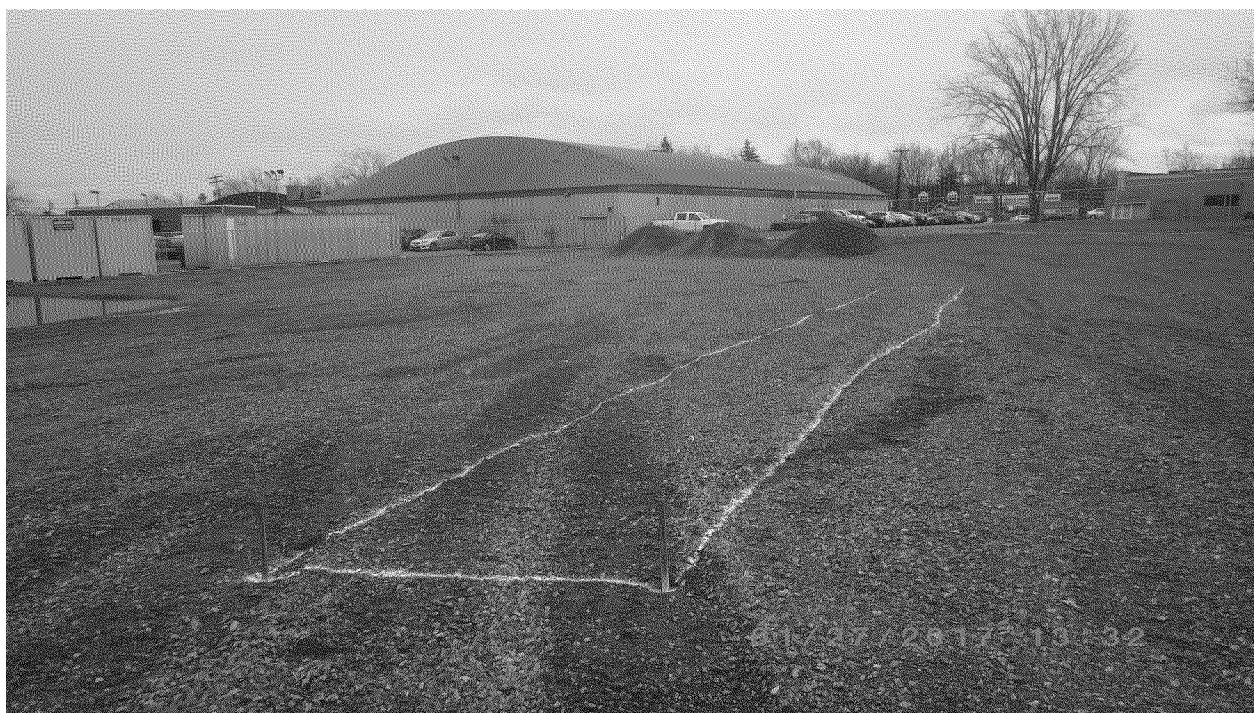
**Photograph 2:** View of Zone 1 located on the west side of Area 5, measuring 60 feet by 7 feet. Zone 1 was used to conduct gamma survey of trees selected for sampling.

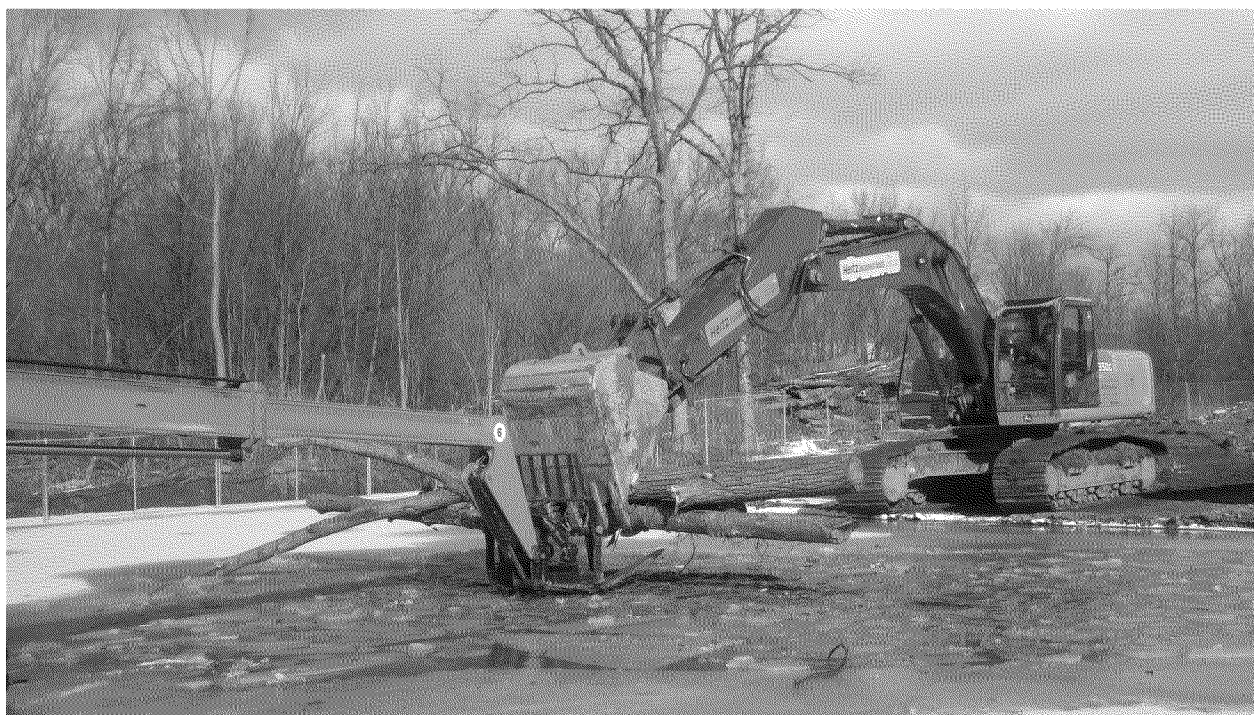
**Photograph 3:** View of trees removed from Area 5 which were being relocation from the initial staging area to the designated zones within Area 5.

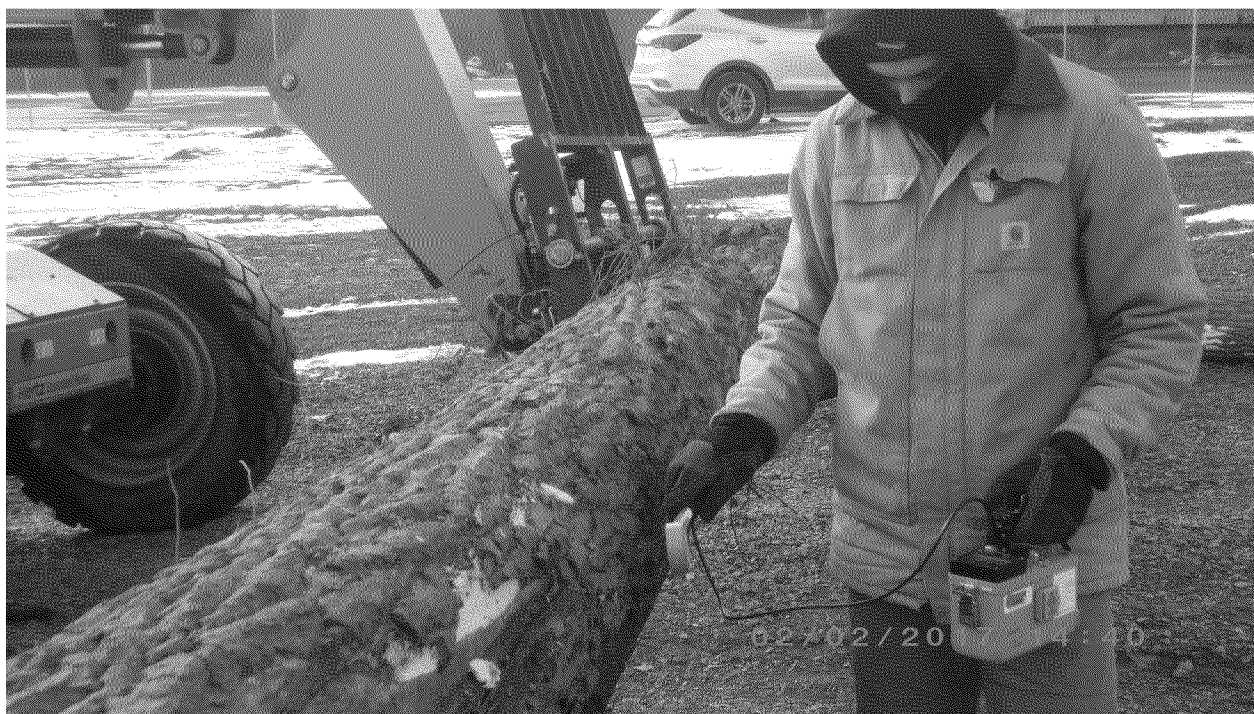
As the trees were being relocated from the initial staging location to the predetermined zones in Area 5, the entirety of each tree was screened/surveyed for gamma radiation using a Ludlum Pancake Probe in order to obtain a qualitative average reading, and ensure that no tree exceeded EPA's SSSL of 40 cpm established for Zone 1 and 47 cpm established for Zone 2. The majority of the trees surveyed for gamma radiation were staged in Zone 2. Trees selected for sampling were moved to Zone 1 and then thoroughly surveyed again for gamma radiation.

**Photograph 4:** View of Weston Solutions Inc., Removal Support Team member 3 (RST 3) member conducting gamma screening/survey of a tree utilizing a Ludlum Model 3 Pancake Probe prior to staging the tree in Area 5.

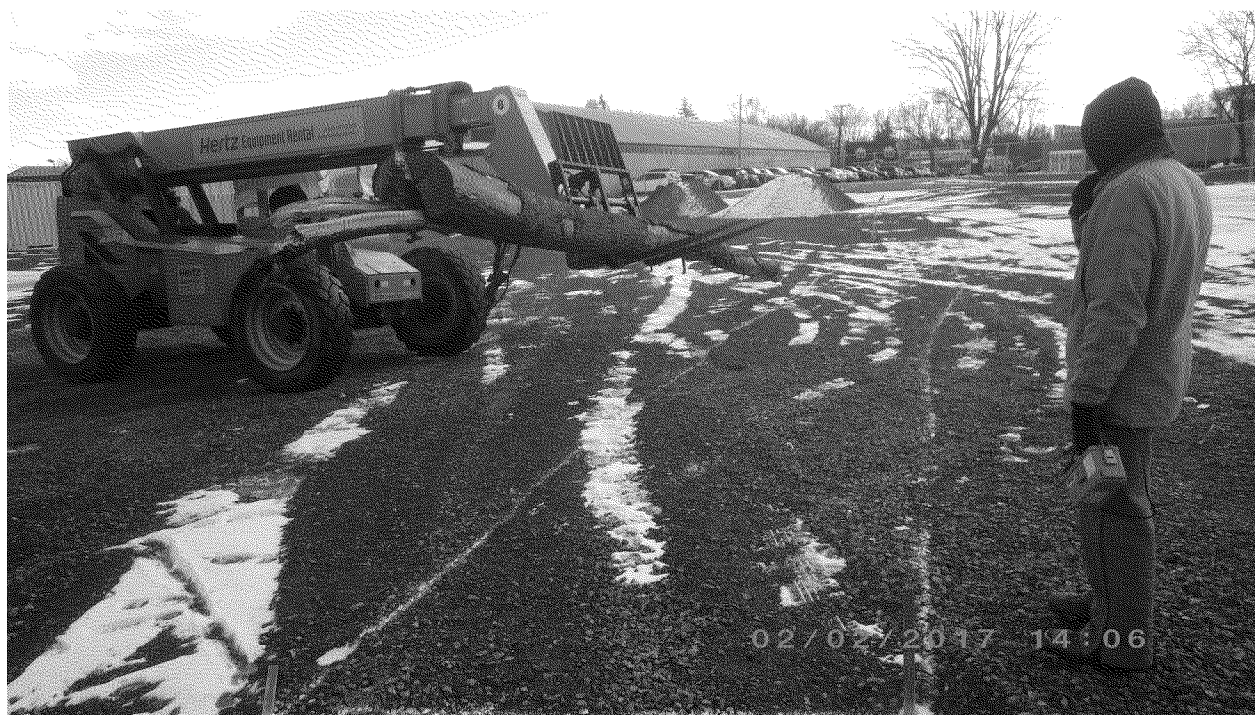
**Photograph 5:** View of U.S. Environmental Protection Agency's (EPA) Emergency and Rapid Response Services (ERRS) contractor, Guardian Environmental Services (GES) staging a preselected tree in Zone 1 for gamma screening/survey and sampling.

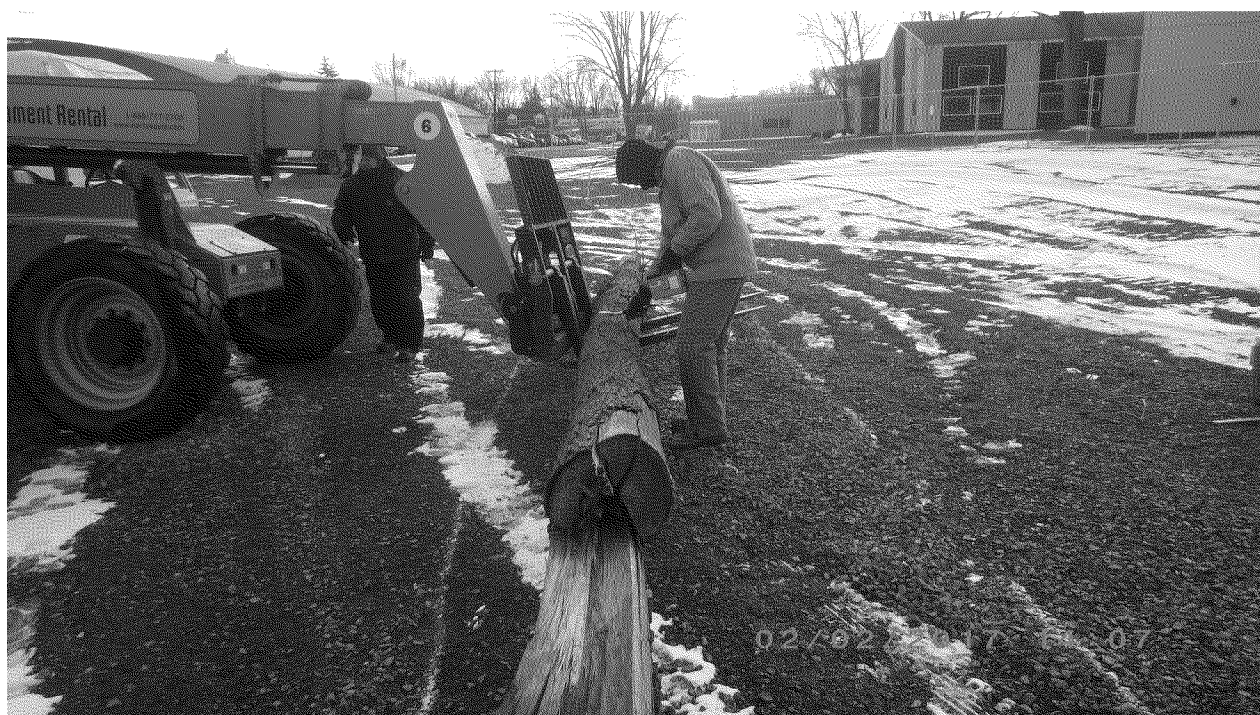
**Photograph 6:** View of RST 3 member conducting gamma screening/survey of a predetermined tree in Zone 1 prior to sampling.

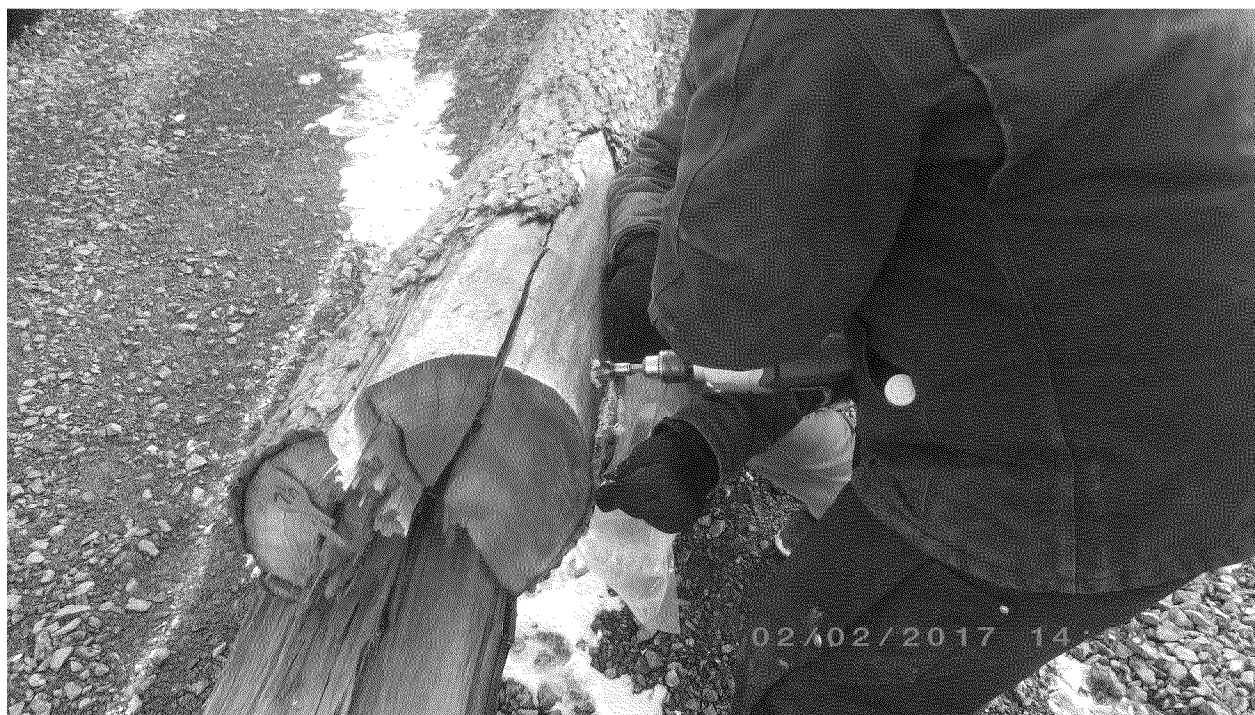
Utilizing a hand-held electric drill equipped with an auger bit, RST 3 collected samples from the tree trunks staged at Zone 1. The samples were collected at the base of each tree by drilling from the exterior of the trunk to the center, such that every ring within the tree was sampled. Approximately 5 to 7 boring were required to attain the sample volume needed for analysis. The extracted samples from the tree borings were collected in a clean polyethylene bag. The sample volume collected from each tree was transferred into a 16 oz plastic jar for quantitative gamma spectrometry analysis utilizing the onsite HPGe detector.

**Photograph 7:** Utilizing a hand-held electric drill equipped with an auger bit, RST 3 collected samples at the base of each tree by drilling from the exterior of the trunk to the center, such that every ring within the tree was sampled.

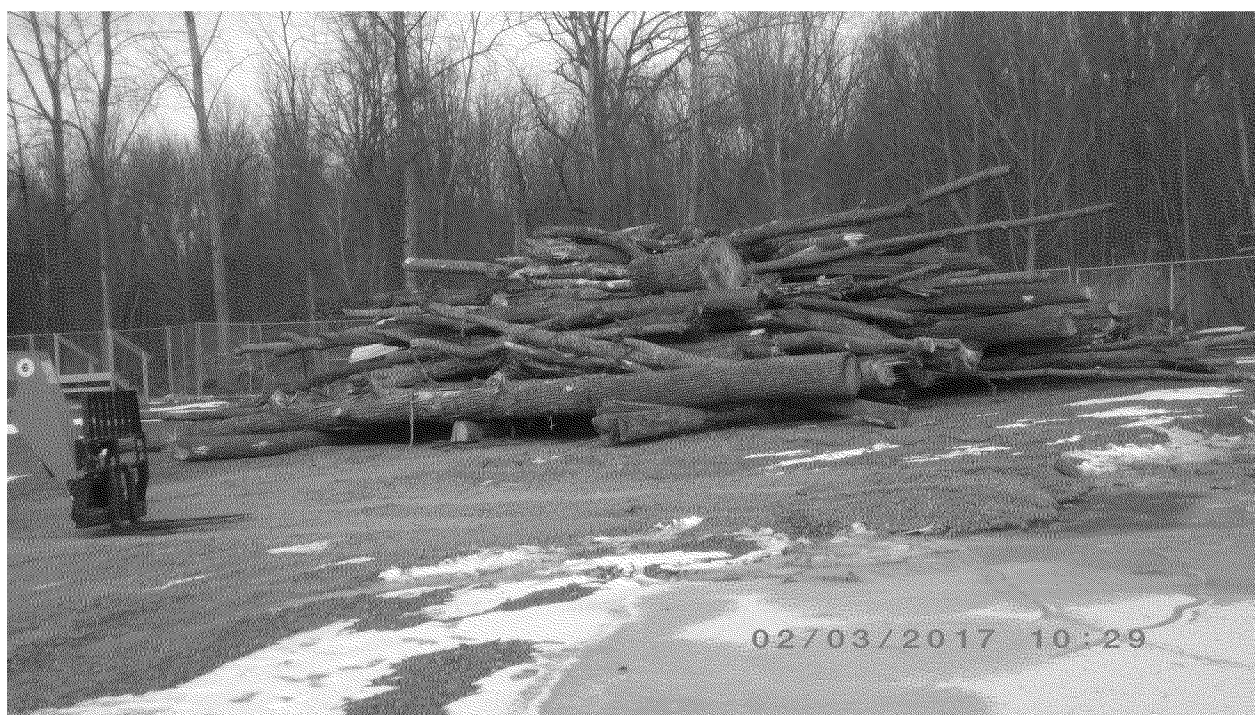
**Photograph 8:** View of Zone 2 located on the north side of Area 5, measuring 60 feet by 30 feet. Zone 2 was used to stage the remaining trees after they were surveyed for gamma radiation.

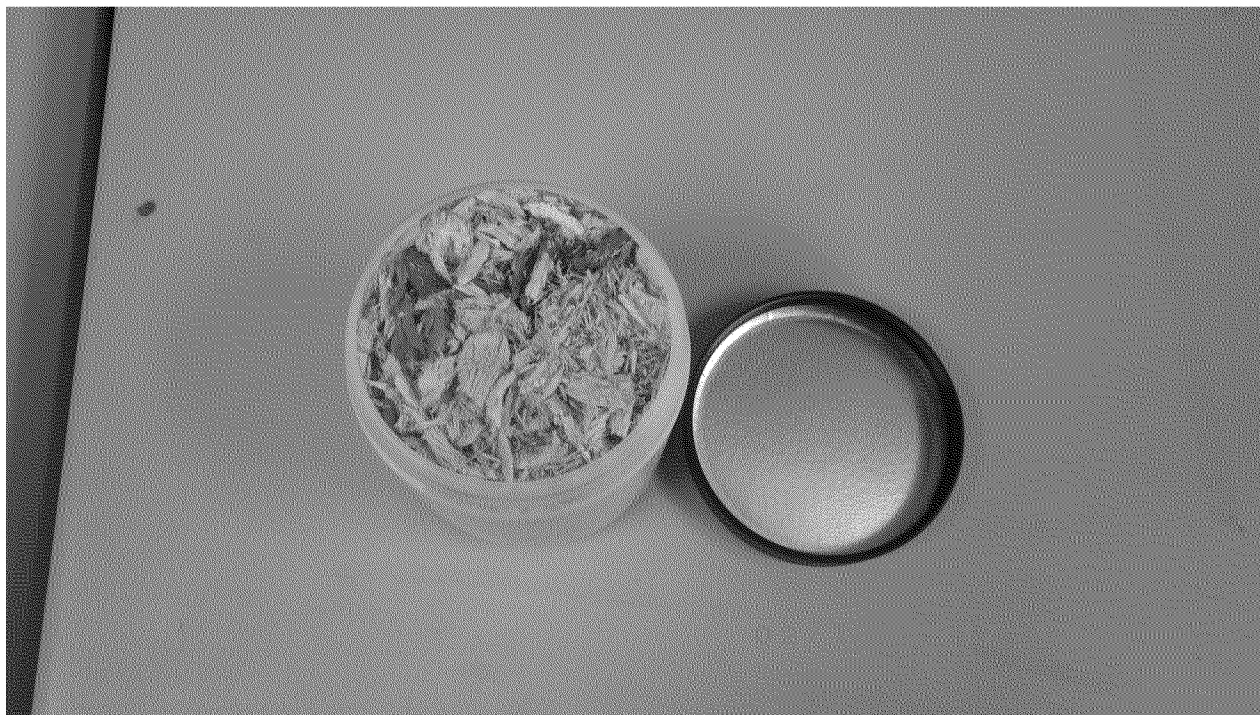
**Photograph 9:** View of a tree boring sample. Approximately 5 to 7 boring were required to attain the sample volume needed for analysis. The extracted samples were collected in a clean polyethylene bag. The sample volume collected from each tree was transferred into a 16 oz plastic jar for quantitative gamma spectrometry analysis utilizing the onsite High-Purity Germanium (HPGe) detector.
